This report is being issued to create renewed awareness of details of the long standing problem, a holistic solution for which is still eluding the various agencies. A recent letter to Birkrigg owner K.Leveredge from Ben Wallace advised by LCC position only reiterates the vulnerability of the low laying area (see Flood Risk Map attached). Flood Management legislation mandates Section 19 reports by LCC (The Lead Flood Authority), which whilst noting this flooding have had little effect. The following FLAG report suggests areas and actions that we believe should be considered to mitigate this vulnerability and alleviate the hardship caused.

**FLAG report, comment and request for action:**

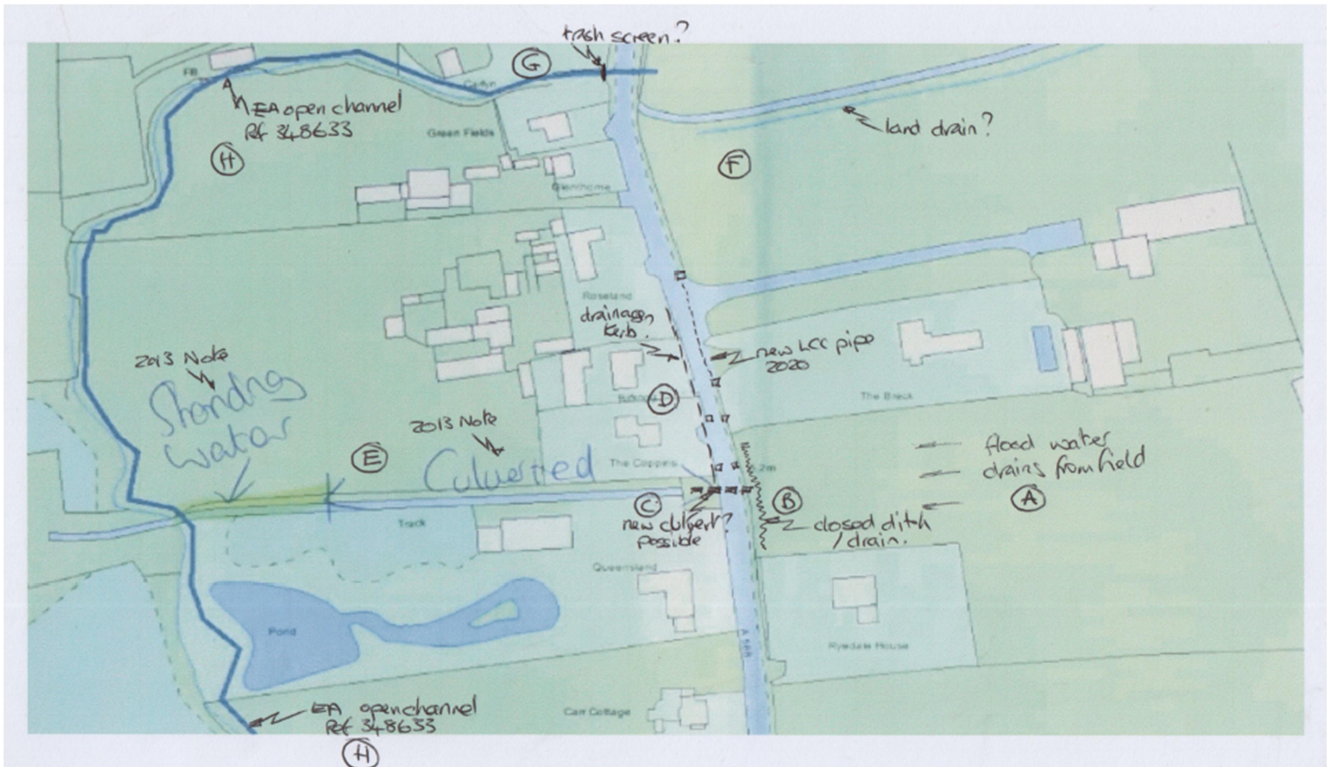
**Location: Area View**

The plan used above from 2013 notes in blue (ref E) the Queensland pipe culverted and standing waters. The same conditions still apply and occur at numerous property flooding events, which have happened since.

The surface water from the field (ref A) used to flow into a water course which has is now filled consequently the water flows onto the A588 causing flooding with the inability of the road drainage to cope.

LCC have installed a new pipe in 2020, and also new road gully's in the past, however these soon silt up with the water flow from the field (ref A) and the piped culvert (ref E) upon which they rely, easily floods.  
As a FLAG we have requested Information with regards surface water drains and foul drains in this area.  
Can WBC, LCC or UU supply this for our information?  
The current system of gully cleaning/unblocking relies on the public reporting system. Does the LCC maintain a list/register of gullies that require lots of cleaning because of silt, and this information being used to target areas for increased scrutiny and preventative action?

Notwithstanding the piped culvert water still stands as indicated in 2013 (ref E)  
The open watercourse (ref H) 'Kiln Lane Pool' - EA id 348633, drains the local area into 'Wardleys Pool' EA id 376083.  
MSFW minutes of Mar/2014 indicate a silt survey was carried out by EA. Can the EA confirm when the next survey is planned, and what can be done with regards to improving drainage flows for the area.

Can LCC consider re-establishment of the watercourse and introduction of a culvert/pipe under the road.  
The field to the north (ref F) uses this solution.  
Can WBC or LCC advise if there are specific farming techniques that can be recommended or mandated to reduce run-off to the A588?  
Does LCC have powers and or road traffic responsibilities that can be used mandate actions to prevent the landowner flooding the road and increasing accident risks?

Removal of the unapproved pipe would assist water flows. This was surveyed and noted in 2013 without action.  
The latest minutes of the MSFW meeting notes an action for EA , can they advise when they will contact the owner and what the course of action may be requested. If he is to be requested to remove the pipes
