HAMBLETON FLAG REPORT MAY 17 – 2021

For consideration at Planned Meetings
the WBC / Flag Meeting 17th May 2021 and
the MSFW meeting circa 20th May and
this is our report for the Flood Forum 27th May

1 COPPINS/BIRKRIGG –CARR LANE - PROPERTY & HOUSE FLOODING

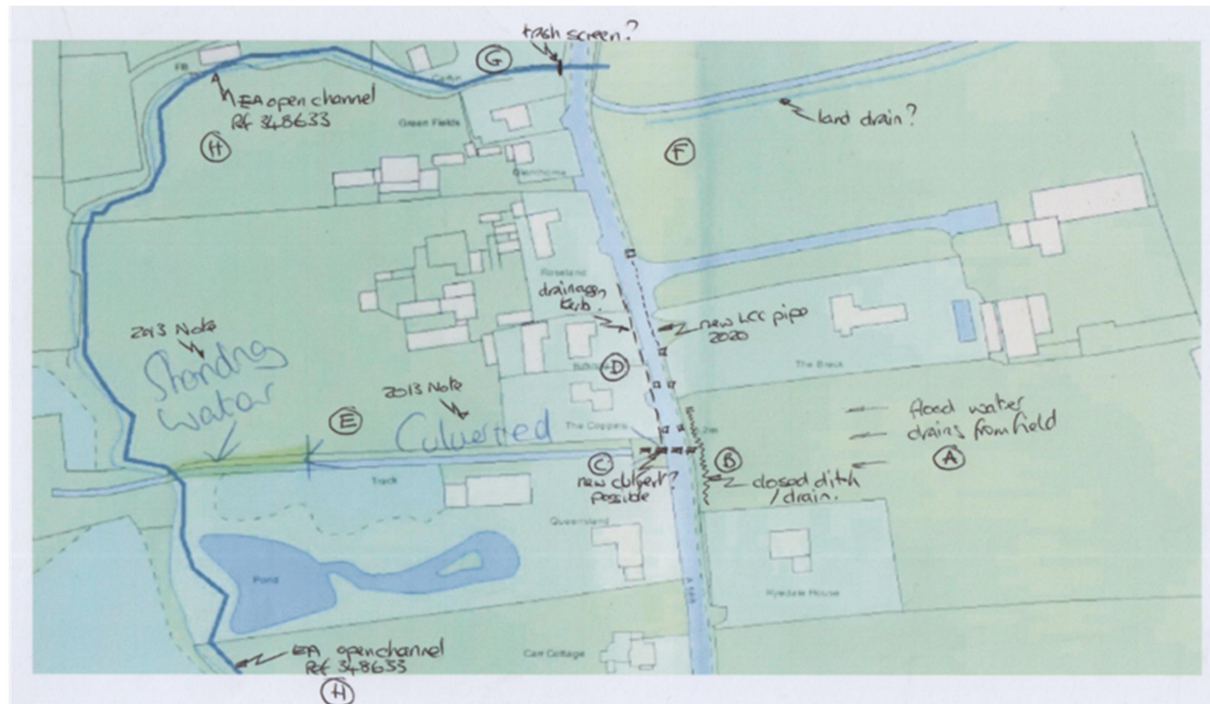
AREA PLAN

- 1-Field drainage and filling in of ditch (Field Owner)
- 2-Carr Lane / A588 blocked gullies (LCC)
- 3-Carr Lane / A588 blocked underground pipes (UU)
- 4-Carr Lane / A588 lack of traffic management during flood event, forces water waves onto properties (LCC)
- 5-Drainage ditch restricted by unapproved piping by property owner (Queensland)
- 6-'Wardleys Pool' & 'Kiln Lane' watercourses lack of desilting (property owner? / EA)
- 7-'Wardleys Pool' flap valve restricts flood flows at high tides(EA)

The plan used above from 2013 notes in blue (ref E) the Queensland pipe culverted and standing waters. The same conditions still apply and occur at numerous property flooding events, which have happened since.

The surface water from the field (refA0 used to flow into a water course which has now been filled consequently the water flows onto the A588 causing flooding with the inability of the road drainage to cope.
Can LCC consider re-establishment of the water course and introduction of a culvert/pipe under the road?
The Field to the North (ref F) uses this solution.
Can WBC or LCC advise if there are specific farming techniques that can be recommended or mandate to reduce run-off to the A588?
Does LCC have powers and or road traffic responsibilities that can be used to mandate actions to prevent the landowner flooding the road and increasing accident risk

LCC have installed a new pipe in 2020 and a new road gullies in the past, however these soon silt up with the water flow from the field (ref A) and the piped culvert upon which they rely, easily floods.
As a FLAG we have requested information with regards surface water drains and foul sewers in this area.
Can WBC, LCC or UU supply this for our information?
The current system of gully cleaning/unblocking relies on the public reporting system. Does the LCC maintain a list/register of gullies that require lots of cleaning because of silt , and is this information being used to target areas for increased scrutiny and preventive action.

The A588 road level has risen with various constructions and resurfacing reducing kerb heights.
Can LCC respond to suggestions that have been made with regards drainage kerbs (beany blocks) on the West side of the A588 in front of the vulnerable properties (ref D) preventing /reducing ingress into the properties? Of course the successful operation of this would require the 'Queensland' Culvert (ref E) to be flowing sufficiently.
Can WBC, LCC introduce/ install speed control measures so as to prevent 'waves' of water being created by inconsiderate motorists. These could be permanent that could be switched on or warning signs that be left with residents with permission to deploy. The flooding is greatly exacerbated by these bows waves of water created by the traffic.

Removal of the unapproved piped 'Queensland Culvert' would assist water flows. This was surveyed/noted in 2013 without action. The latest minutes of the MSFW meeting notes an action for EA, can they advise when they will contact the owner and what course of action may be requested and if this will include removal of the pipes.

Notwithstanding the piped culvert water still stands as indicated in 2013 (ref E)
The open watercourse (ref H) 'Kiln Lane Pool' – EA id 348633, drains the local area into 'Wardleys Pool' EA id 376083. MSFW minutes of Mar 2014 indicate a silt survey was carried out by EA. Can the EA confirm when the next survey is planned, and what can be done with regards improving drainage flows from the area.

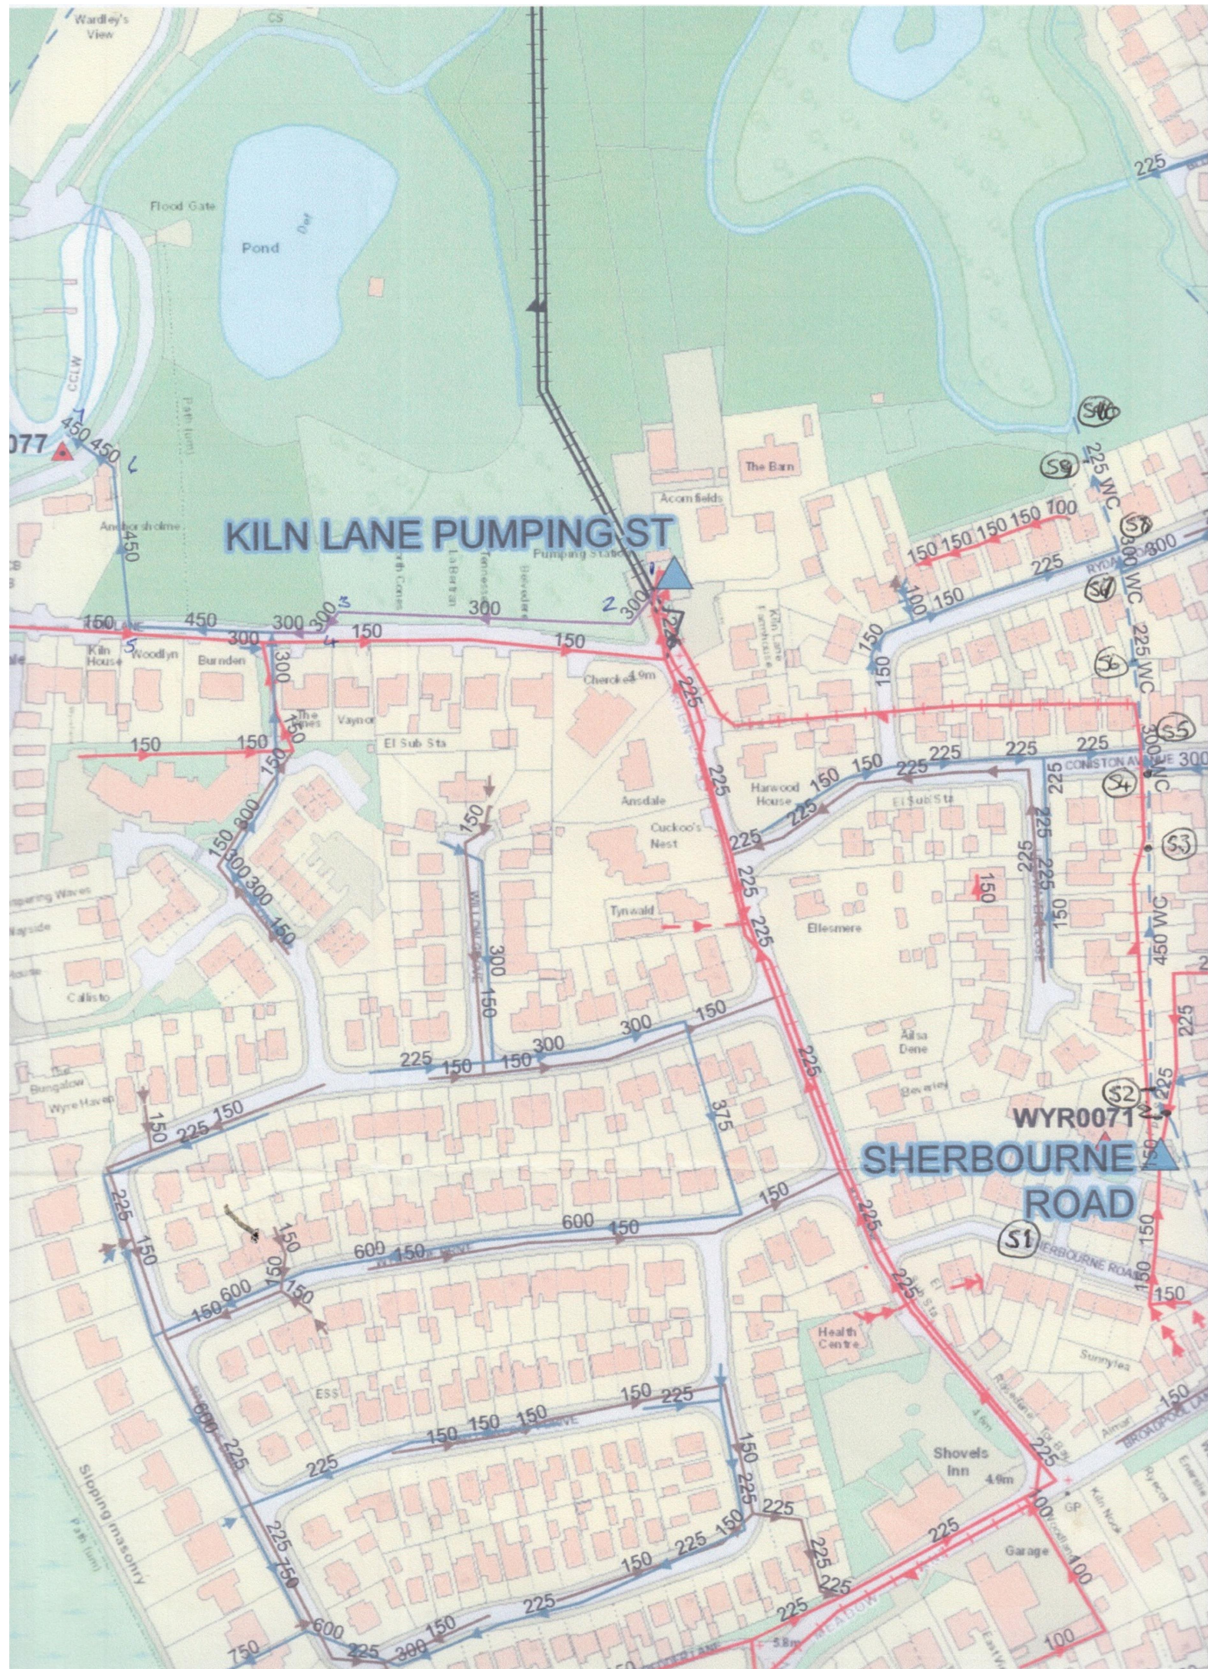
AREA PLAN

The general plan included here shows the areas relative to Kiln Lane and Sherbourne flooding. Work has been done with regards Rydal Road (Kiln Lane Water Course) out fall (ref S10) and the associated piped water course and recently the Kiln Lane Water course outfall (ref K16). However essentially the same conditions still apply in that flooding risk still exists for when heavy rainfall coincides with a high tide. The manholes and gullies in Kiln Lane, during flooding can all be observed surcharging up and flooding the road. At Sherborne Rd the flooding regularly enters houses, along Kiln Lane the roads are flooded to 300 or 400 mm (notwithstanding a central high area). Because the gullies and the manholes surcharge is was thought that Kiln lane was a combined surface and fouls system; it would now appear that it is separate, our requested for information showing this is outstanding. Our report covers:

This surface water drains from Sherbourne Road to the piped water course which outfalls into Kiln Lane Watercourse. The system is shown on the plans (ref S1 to S9) as 450WC, 300WC, 225WC, 300WC, 225WC. Also connected into this system are

Ref S4-S5-300mm diameter WC pipe under Footpath South -Coniston Ave-Footpath-North responsibility UU. The WC pipe show reduces in size from 450mm diameter to 300mm diameter, reducing capacity by 56%. There are pipes from road gullies

from 300mm diameter to 225mm diameter, this is a reduction in capacity, compared to the 450mm diameter pipe of 75% !!

It would seem to be quite obvious that over time this pipe has become extremely overloaded and that it is a major factor in the road flooding in Hambleton. Who owns this responsibility?(LCC/UU/WBC/Riparian) and what action can be taken.

Ref F1-F2-F3-F4-F5-F6-F7-F8-F9-F10 are manholes along Kiln Lane, all of which undergo surcharge during flooding events (together with the Surface Water Gullies) and between Ref F7 and Ref F8 air bubbles are seen rising from the road surface above the sewer line.

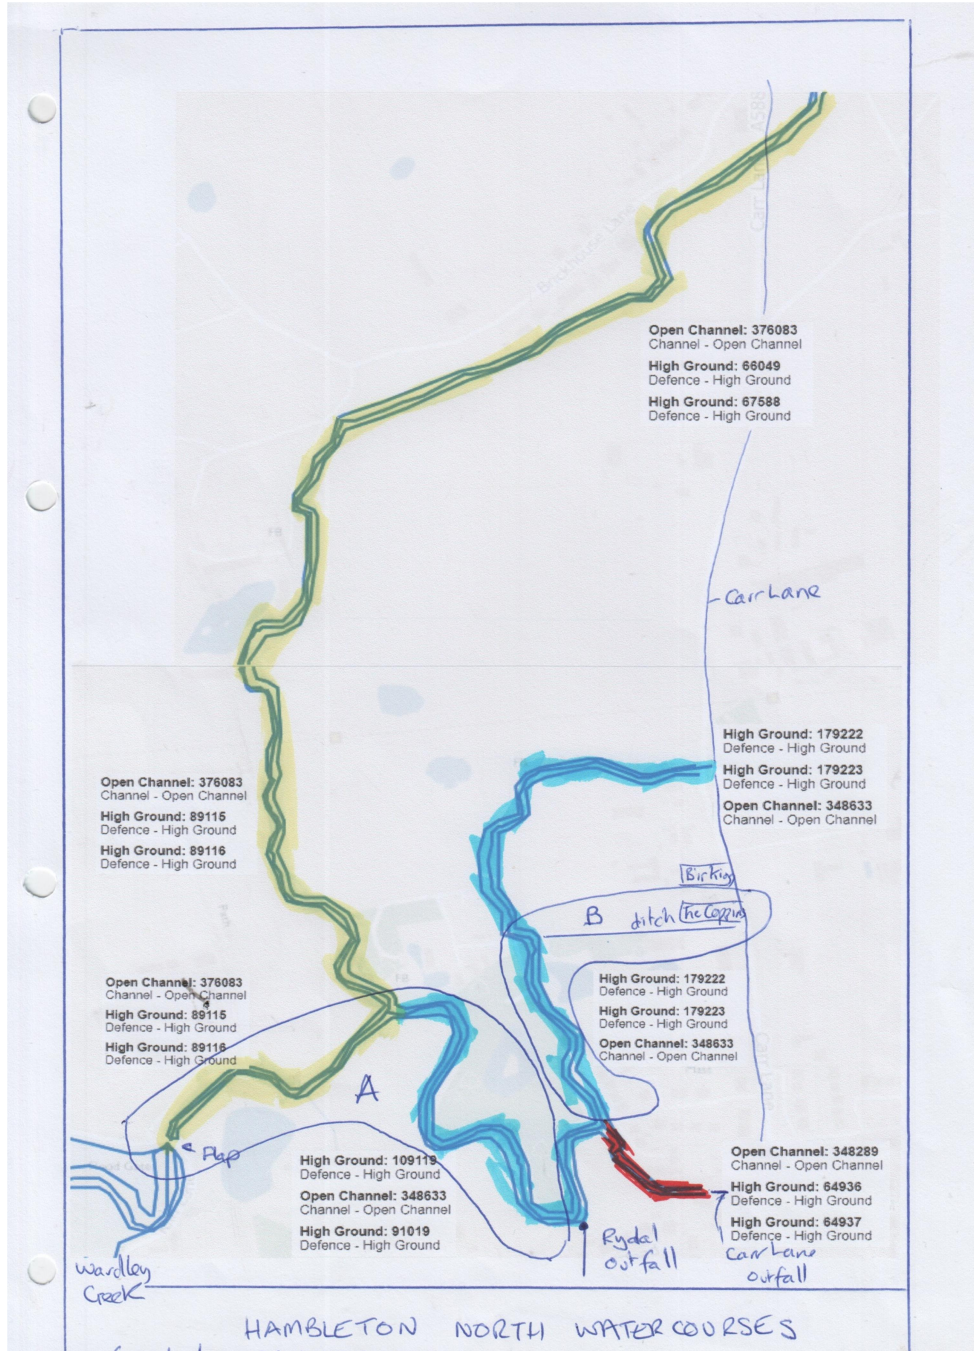
AREA PLAN

- 1-General Silting up preventing flow and causing flooding
- 2-The Outfall Flap and drainage capability improvement to be done with flood defense works

In recent meetings EA has undertaken to review the possibility of increasing the flap valve pipes so to facilitate a longer period of drainage, where level remain high behind. At the the moment a very small tide rise closes the flap
Can EA advise the current status.

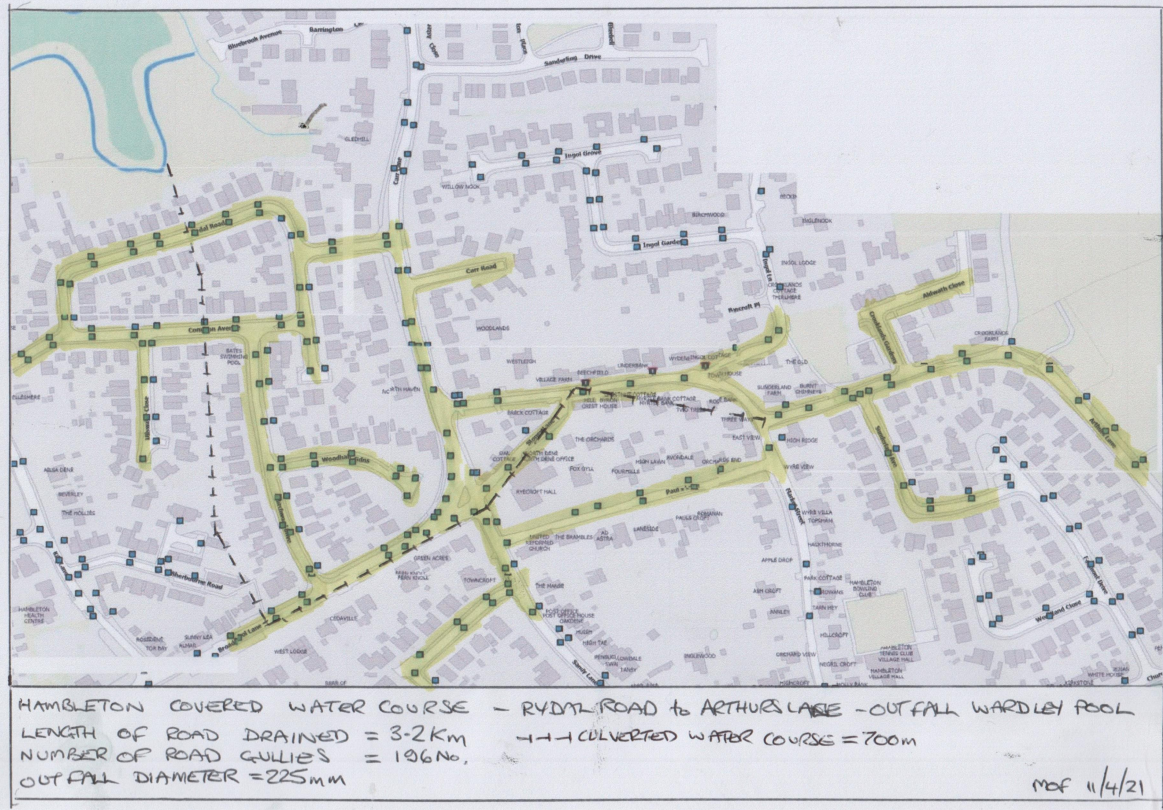
AREA PLAN

This system represents 35% of Hambleton surface water drainage; it has road catchment length of approx. 3119m with approx. 196 road gullies. The outfall into Wardleys Pool is only 225m despite pipes within the system being up to 450mm. The main pipe is a culverted water course of approx. 700m most of which is under riparian ownership. The detail of the lower section is covered under section 2 Kiln Lane/ Sherbourne

- 1-Blocked Gulleys (LCC)
- 2-Blocked Drainage Pipes (UU. Riparian owners)
- 3-Silted Watercourses (EA)

- 1-Carr Lane Gullies reported to LCC and unblocked
- 2-Recent UU survey shows a significant number of significant defects requiring action

Due to the importance of this system to Hambleton we request an overall short term and long term plan for action

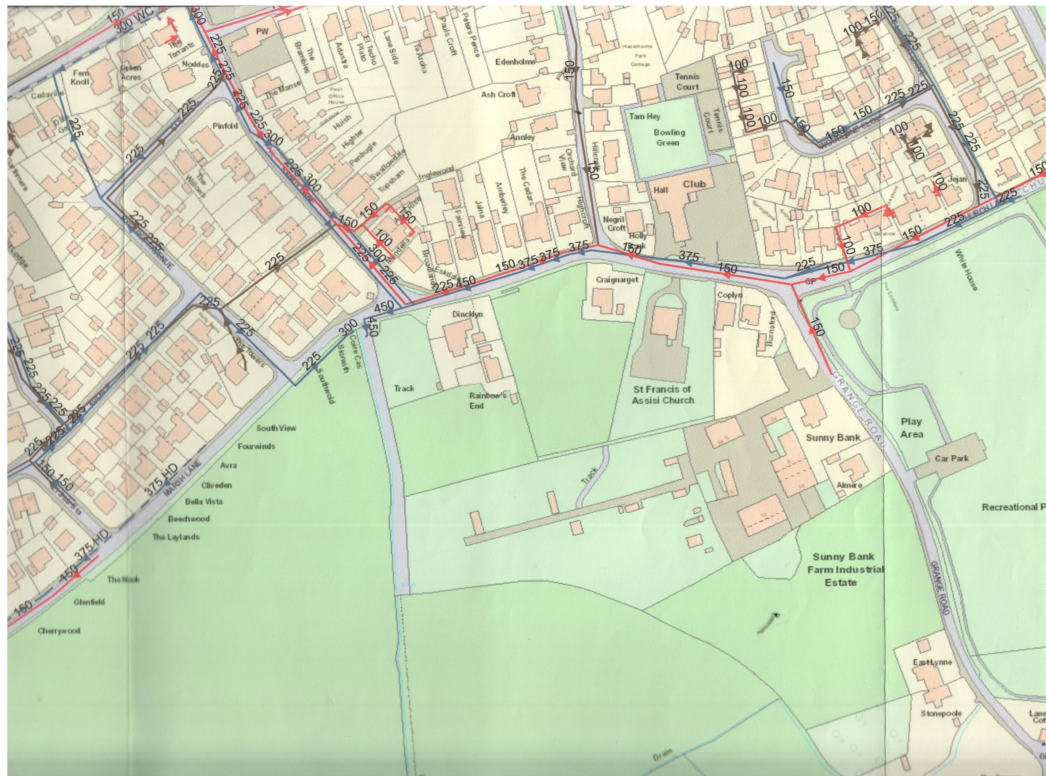
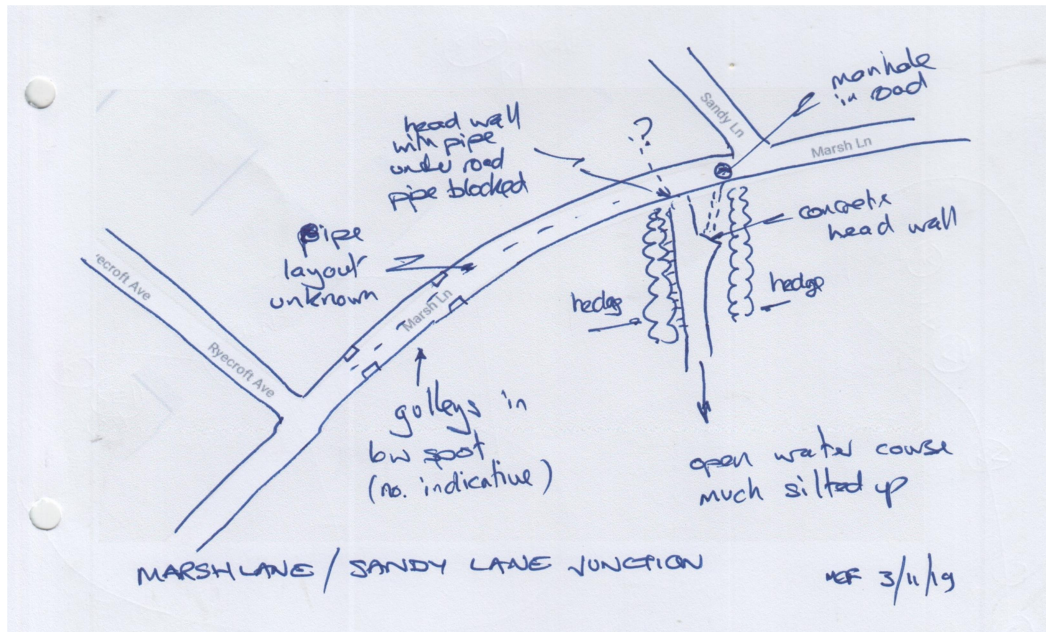
AREA PLAN

The Marsh Lane system drains nearly 500m of road with approx. 33 gullies, there are two outfalls into the open ditch. The outfalls are 50% silted. During heavy rain the roadway floods.

- 1-Blocked Gullies (LCC)
- 2-Blocked Drainage Pipes (UU)
- 3-Silted Watercourses (EA)

- 1-We request survey of the gullies and pipe system to identify action/remedial work requirement
- 2-We request EA survey and desilting of the open ditch through to Pegs Pool

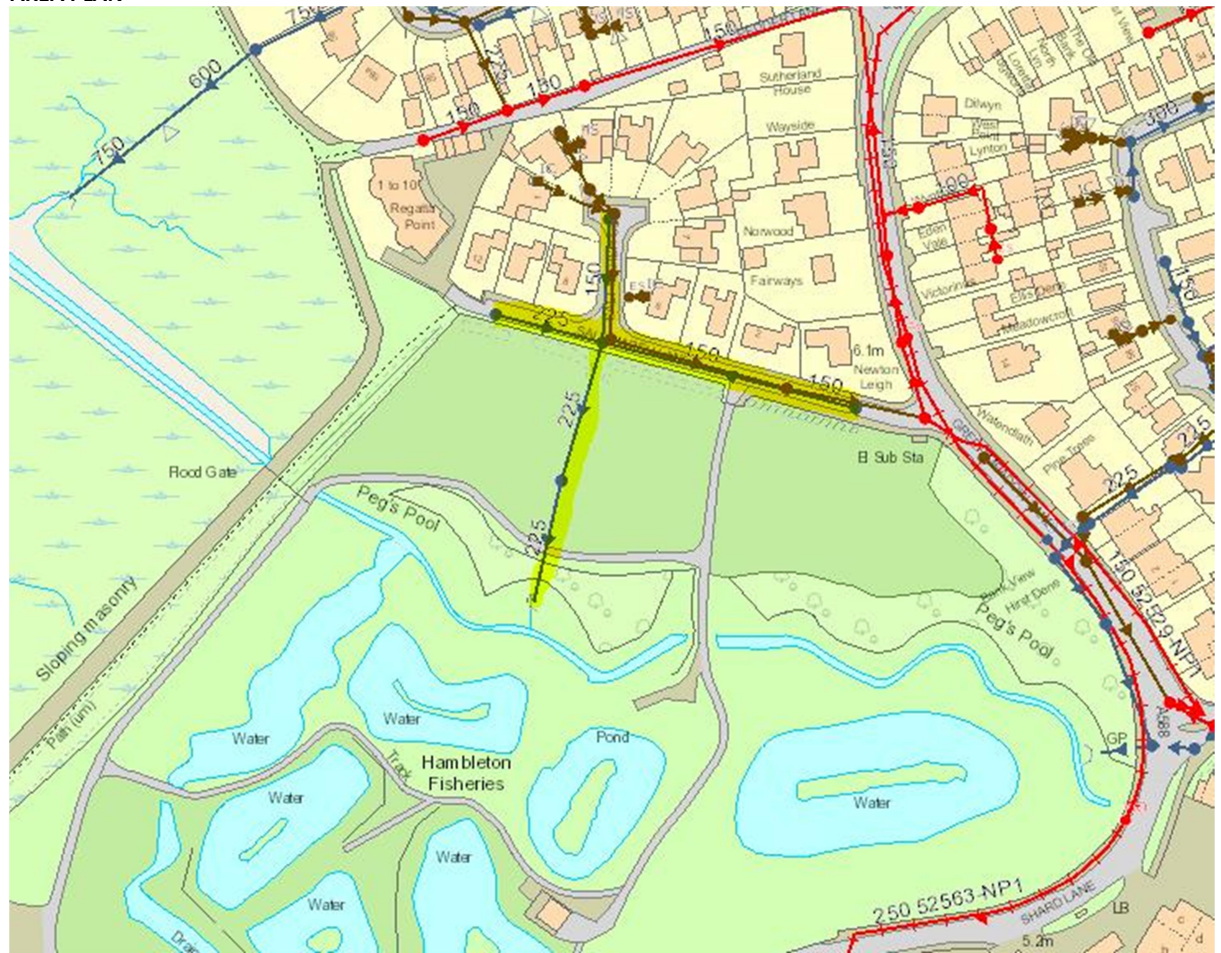
AREA PLAN

Pipework system outfall queried

Dye testing as agreed
