This report is being issued to create renewed awareness of details of the long standing problem, a holistic solution for which is still eluding the various agencies. A recent letter to Birkrigg owner K.Leveredge from Ben Wallace advised by LCC position only reiterates the vulnerability of the low laying area (see Flood Risk Map attached). Flood Management legislation mandates Section 19 reports by LCC (The Lead Flood Authority), which whilst noting this flooding have had little effect. The following FLAG report suggests areas and actions that we believe should be considered to mitigate this vulnerability and alleviate the hardship caused.

**FLAG report, comment and request for action:**

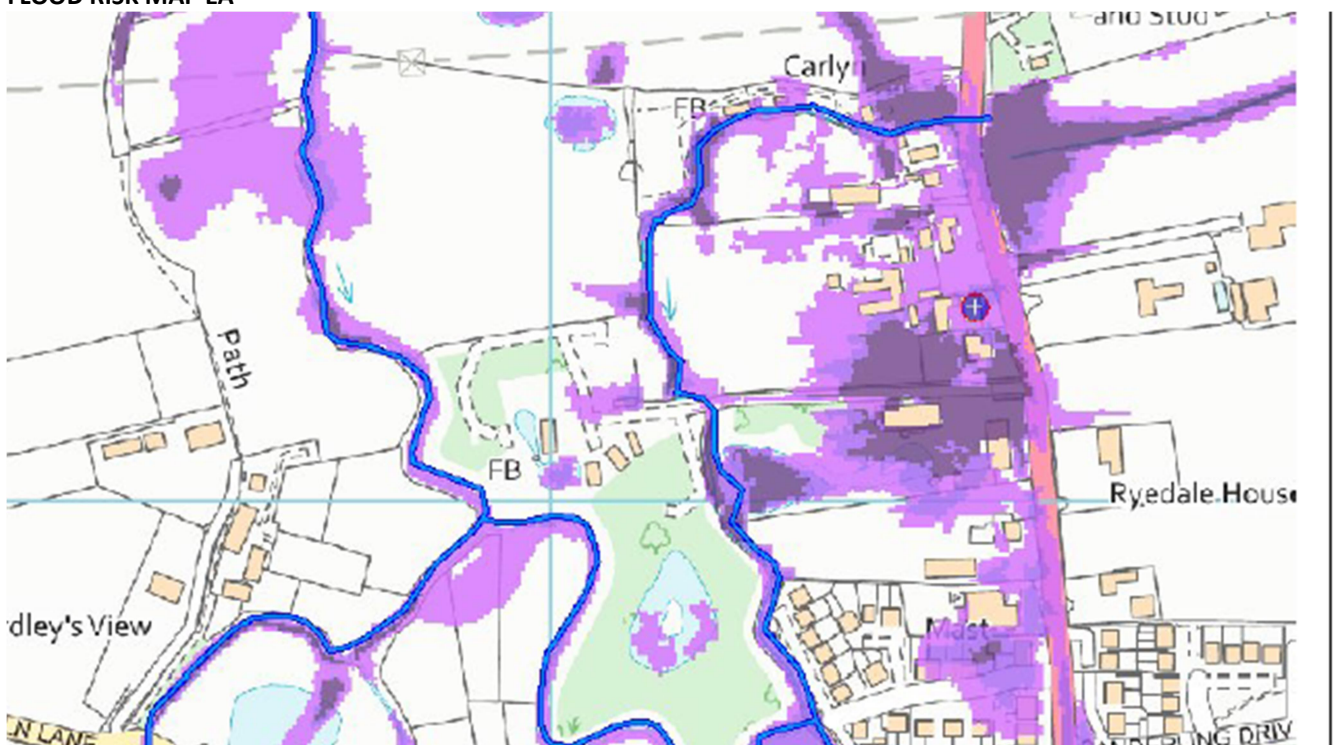
**FLOOD RISK MAP EA**

Notwithstanding the piped culvert water still stands as indicated in 2013 (ref E)  
The open watercourse (ref H) 'Kiln Lane Pool' - EA id 348633, drains the local area into 'Wardleys Pool' EA id 376083.  
MSFW minutes of Mar/2014 indicate a silt survey was carried out by EA. Can the EA confirm when the next survey is planned, and what can be done with regards to improving drainage flows for the area.
