HAMBLETON FLAG REPORT MAY 17 – 2021

For consideration at Planned Meetings
the WBC / Flag Meeting 17th May 2021 and
the MSFW meeting circa 20th May and
this is our report for the Flood Forum 27th May

1 COPPINS/BIRKRIGG –CARR LANE - PROPERTY & HOUSE FLOODING

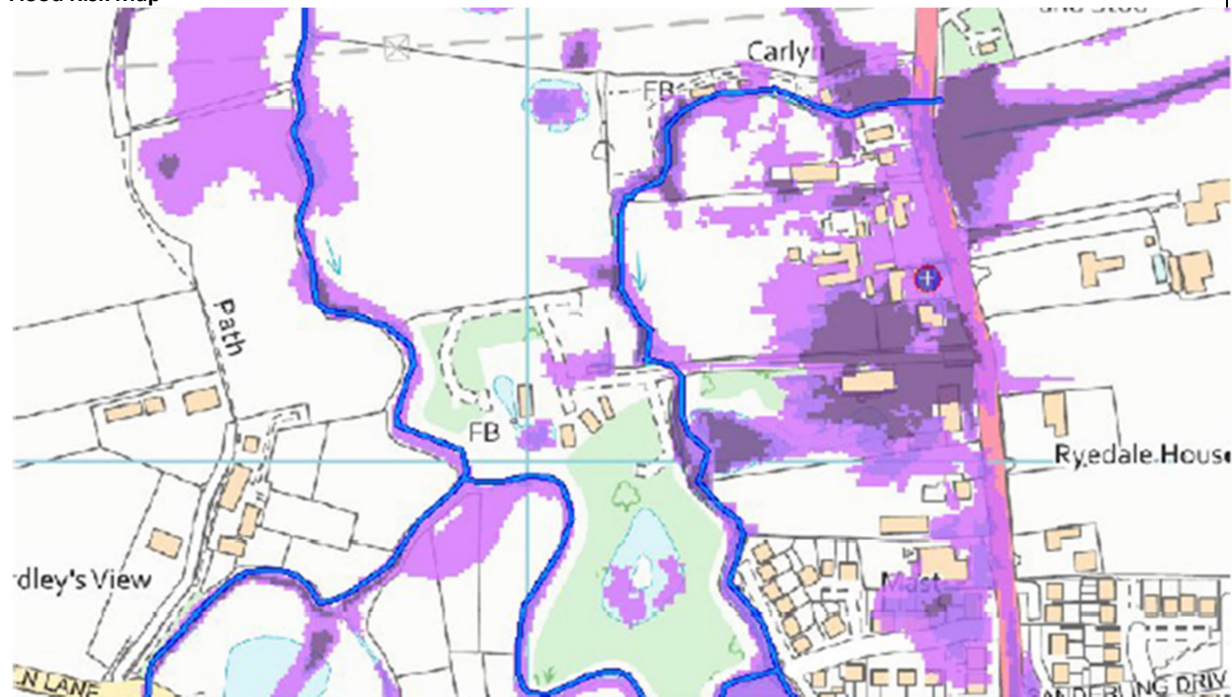
Flood Risk Map

Notwithstanding the piped culvert water still stands as indicated in 2013 (ref E)
The open watercourse (ref H) 'Kiln Lane Pool' – EA id 348633, drains the local area into 'Wardleys Pool' EA id 376083. MSFW minutes of Mar 2014 indicate a silt survey was carried out by EA. Can the EA confirm when the next survey is planned, and what can be done with regards improving drainage flows from the area.
