Wyre Flood Forum

Minutes of meeting held Thursday 10 June 2021
@ 1pm via Microsoft Teams.

Hambleton FLAG report May 17 - 2021

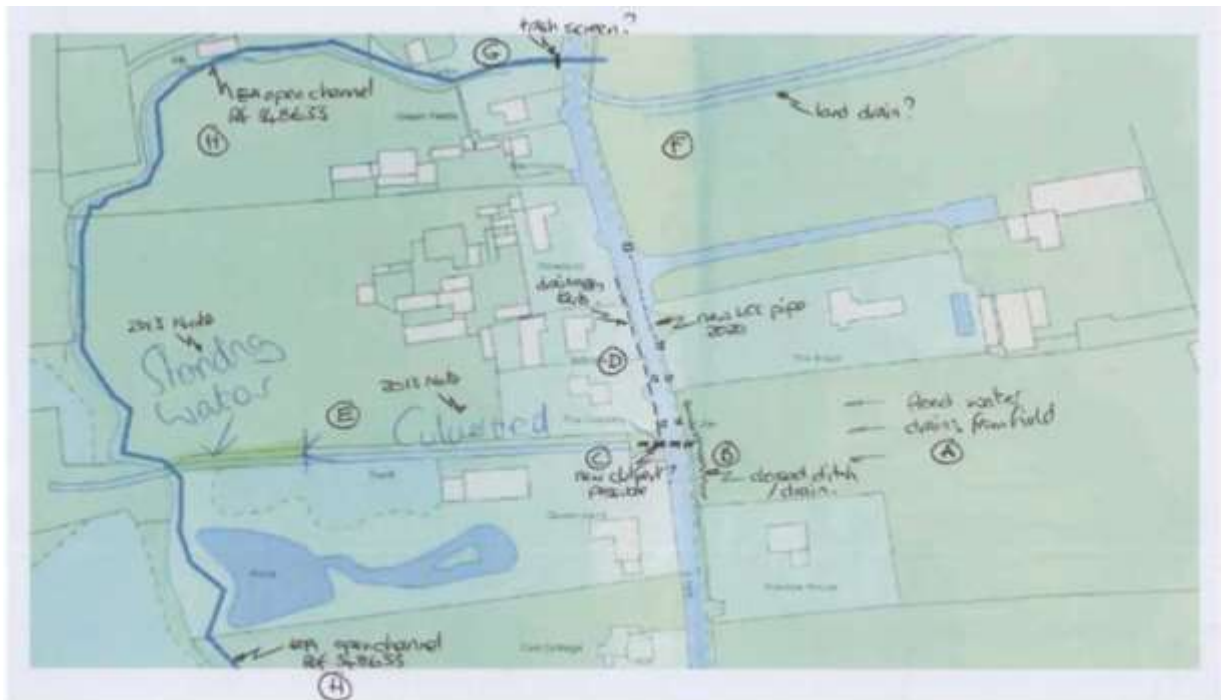
AREA PLAN

The plan used above from 2013 notes in blue (ref E) the Queensland pipe culverted and standing waters. The same conditions still apply and occur at numerous property flooding events, which have happened since.

Removal of the unapproved piped 'Queensland Culvert' would assist water flows. This was surveyed/noted in 2013 without action.

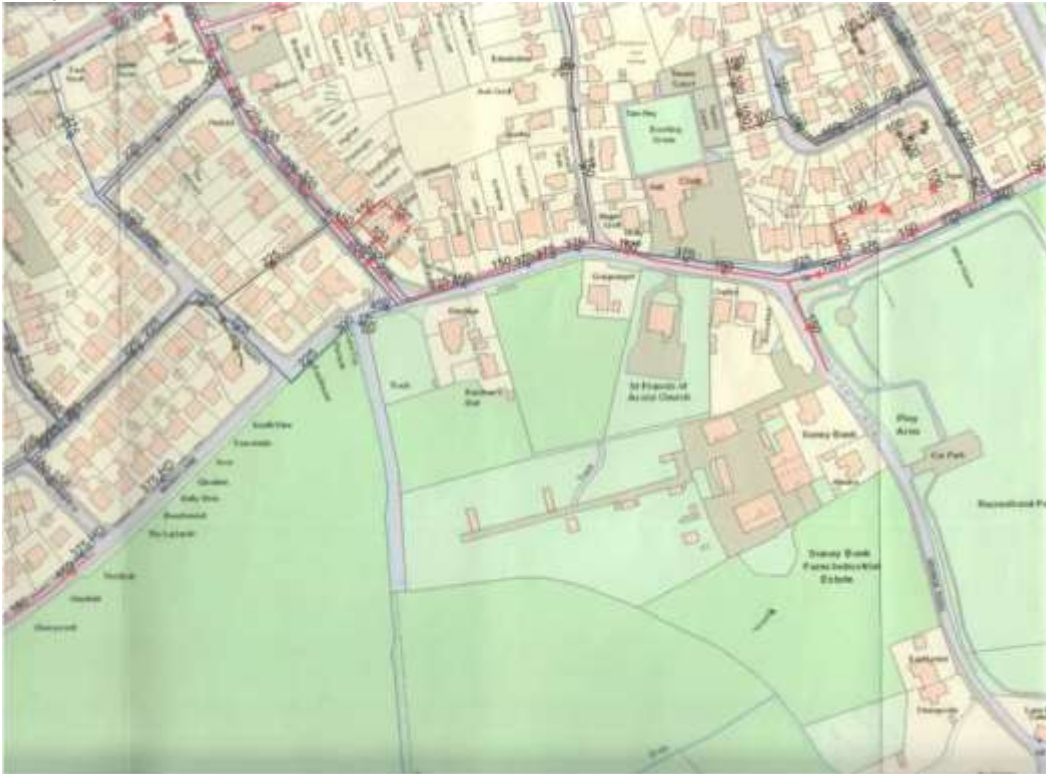
**5 – Marsh Lane
Area plan**

The Marsh Lane system drains nearly 500m of road with approx. 33 gullies, there are two outfalls into the open ditch. The outfalls are 50% silted. During heavy rain the roadway floods.

- 1-We request survey of the gullies and pipe sytem to indentify action/remedial work requirement
- 2-We request EA survey and desilting of the open ditch through to Pegs Pool

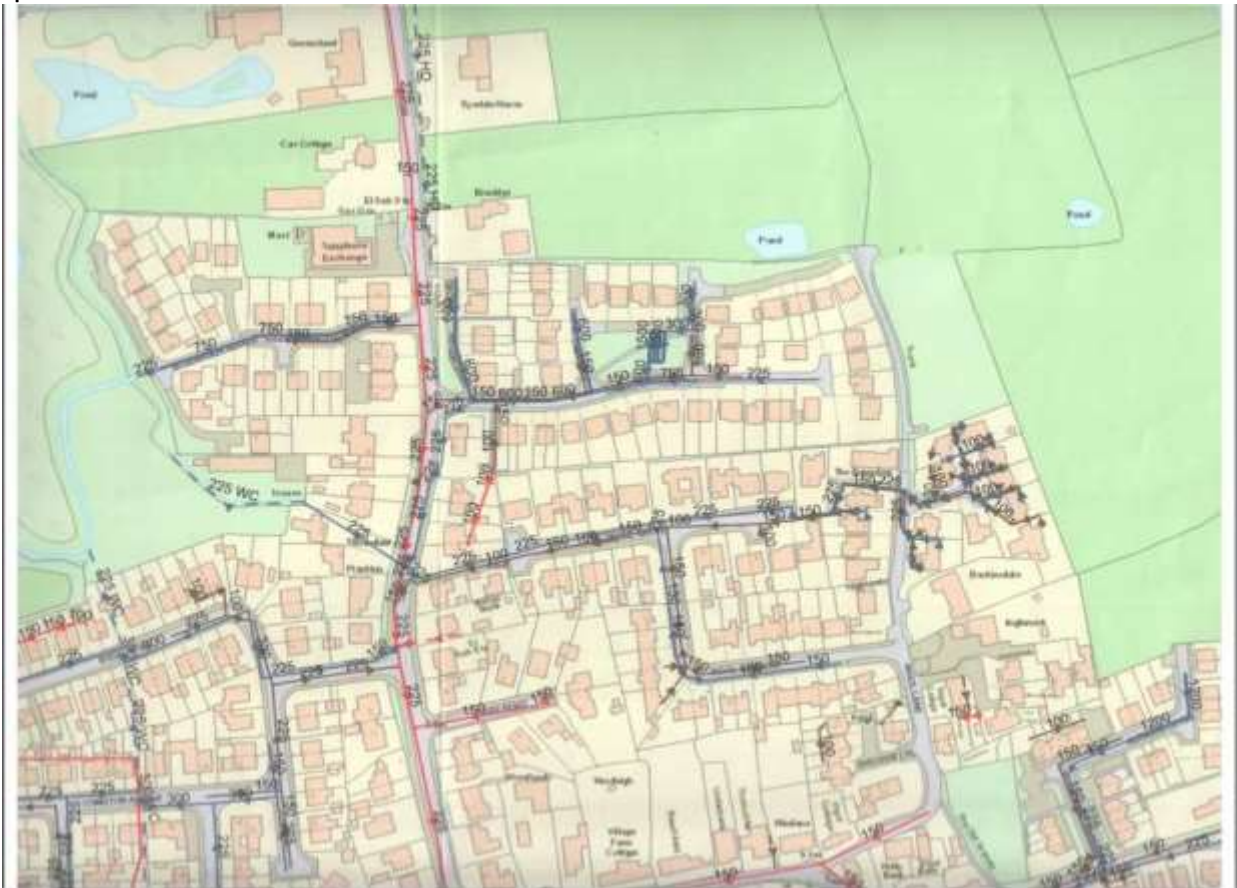
6 – Thistlefield- Carr Lane - Outfall area plan

The main A588 road floods during high rainfall The manholes have water uplifting from them

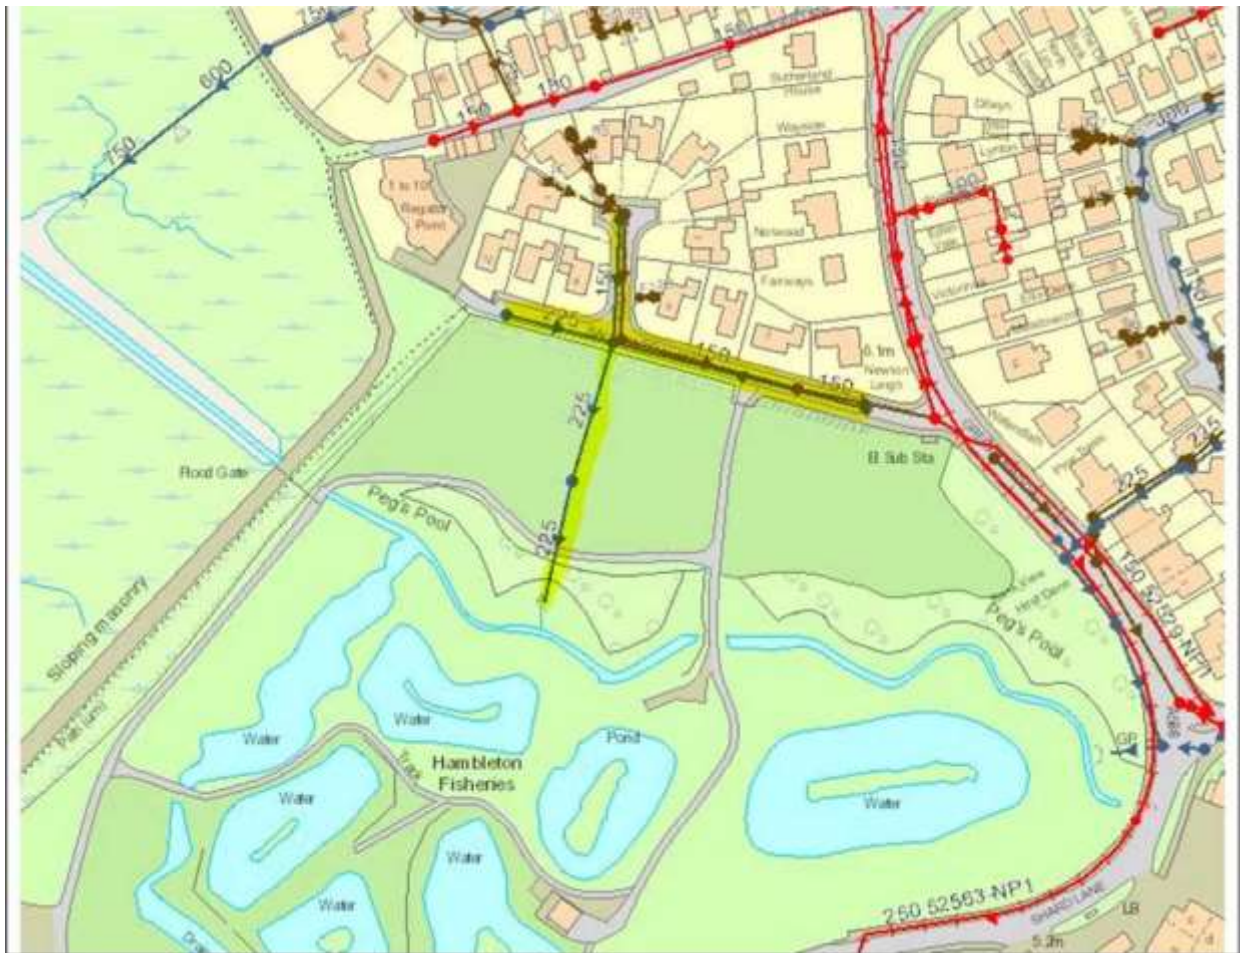
7 - Salt Marsh Lane – Outfall

Pipework system outfall queried
